Report to Historic Scotland on the Recovery of Postcards from the German High Seas Vessel SMS Karlsruhe, Scapa Flow Orkney

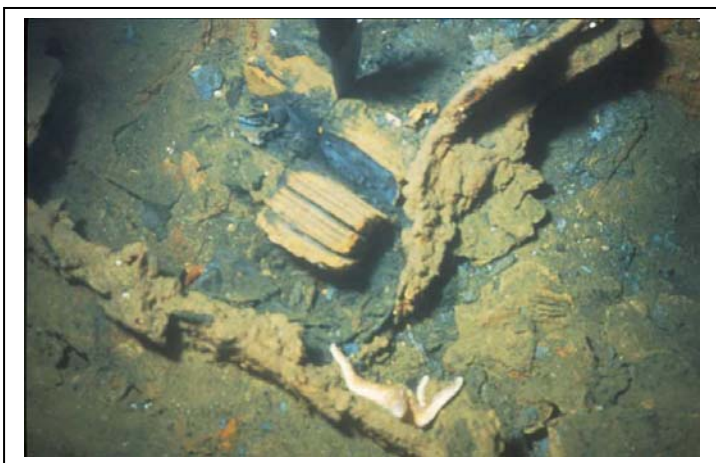
The bulk of the sediment was removed from around the postcards by hand trowel (Image 2). Stacks 1 –3 (Image 3.) were orientated from bottom left to top right on the image with one end of the card on the "floor" of the compartment. Stacks 4-5 were arranged at 90° to these.

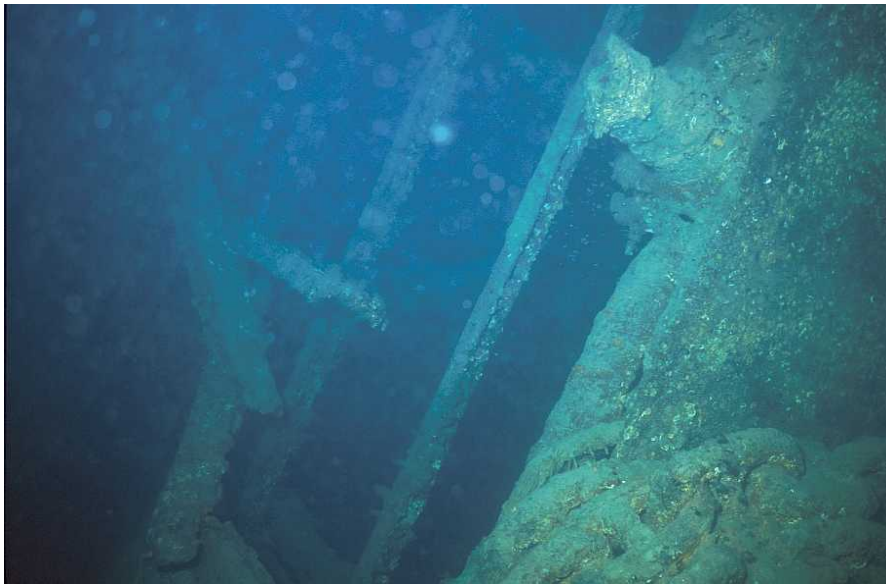
Image 1. Access to bow section containing the postcards.

The SMS Karlsruhe lies on it's starboard side at a depth of approximately 25 – 28 metres. The section of wreck in which the postcards were located was at the forward bow area. Although presenting an overhead environment for the diver access to the area was through an opening in the deck. Figure 1. The postcards were situated approximately 12 metres towards the stern and 3 metres down from the opening.

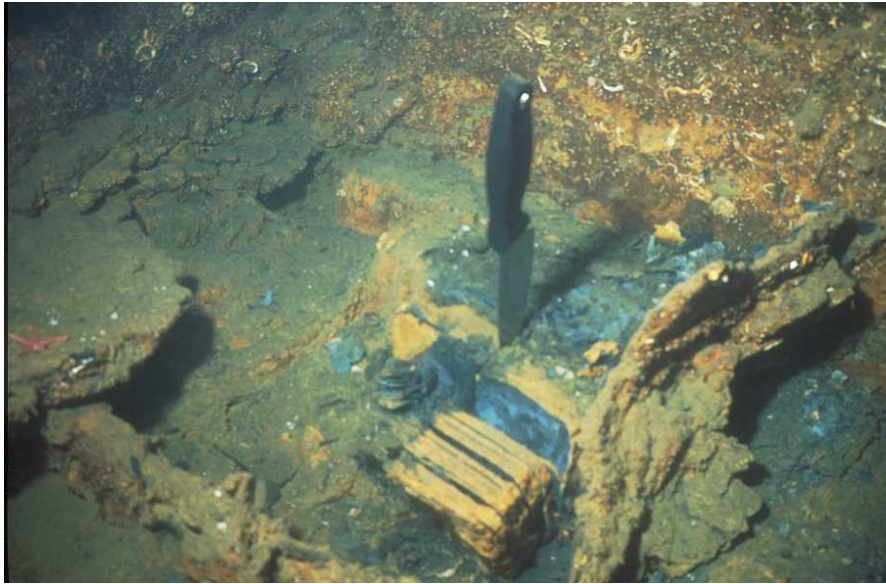
Image 4. Stack one removed showing cards beginning to separate in stack 2 revealing postcard image.

A sharp broad blade knife was then used to separate adjacent stacks of cards.(Image 4).
